# PROJECT PROFILE

## Residential dock rebuild

**Lake Whatcom, WA** Completion: Spring 2009

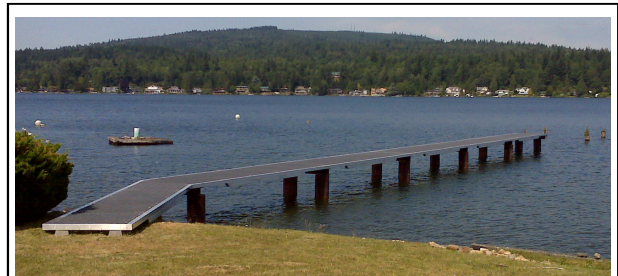
Finished dock on Lake Whatcom, Spring 2009.
